EFFECT OF CORROSION ON END REGION BEHAVIOR OF PRETENSIONED, PRESTRESSED BRIDGE GIRDERS

Darion T. Mayhorn, Bureau of Reclamation, Denver, CO
Cameron D. Murray, University of Oklahoma, Norman, OK
Royce W. Floyd, Ph.D., P.E., University of Oklahoma, Norman, OK
Gary S. Prinz, Ph.D., P.E., University of Arkansas, Fayetteville, AR

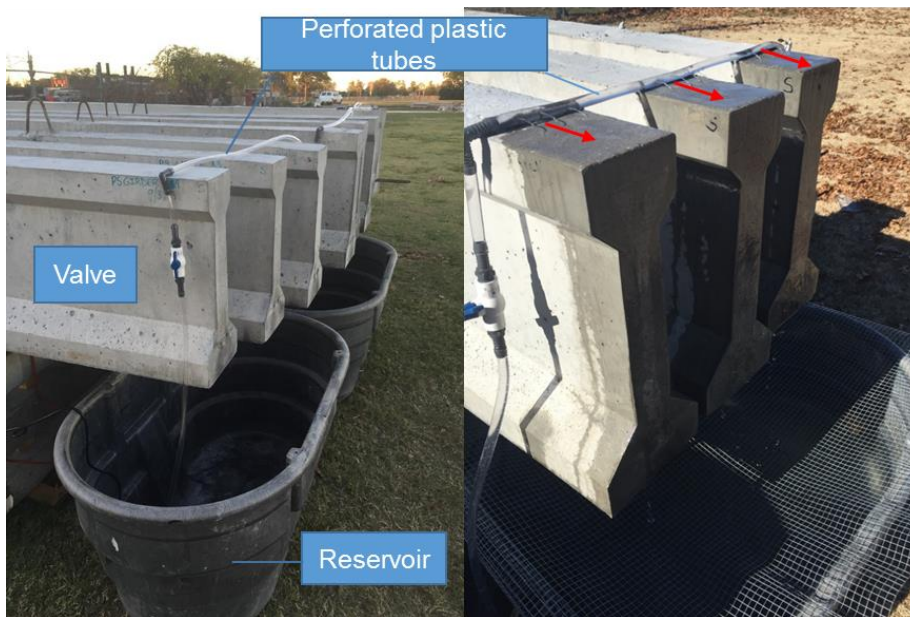
Figure 1. Completed girders placed in corrosion accelerant setup (red arrows indicate the direction of flow from the perforated tubes)

After the girders reached an age of 28 days, they were placed in a corrosive environment consisting of a chloride solution spray to induce end-region corrosion. The use of a chloride spray was intended to simulate the effect of a leaking expansion joint on the ends of the girders similar to that described by previous research^{3,4} and observed by the authors in the field. No end diaphragms or other concrete cover was included on the ends of the beams, as would be present in the field, in order to speed up the corrosion process. Initially, a literature review was performed to understand chloride solutions successfully used for similar applications in previous research, as well as the optimum duration for wet/dry cycles of chloride saturated water.^{6,14} Ultimately, a 5 percent by weight sodium chloride solution was used as the corrosive agent. A large plastic tub was used as a reservoir, with a submersible pump to circulate the chloride solution over one end of the beams. Perforated plastic tubes were bonded to the beams approximately 6 in. from the beam ends to correlate with the typical distance exposed to leaking joints observed by the authors for beams in the field. The perforations consisted of four 3/32 in.-diameter holes spaced to evenly spray the chloride solution over the beam ends. A valve was used to control the flow rate of the chloride solution through the perforated tubing. The final arrangement is shown in Figure 1. A cycle time of two hours on and two hours off was chosen based on the literature review, limitations of available timers, and to ensure drying between cycles.

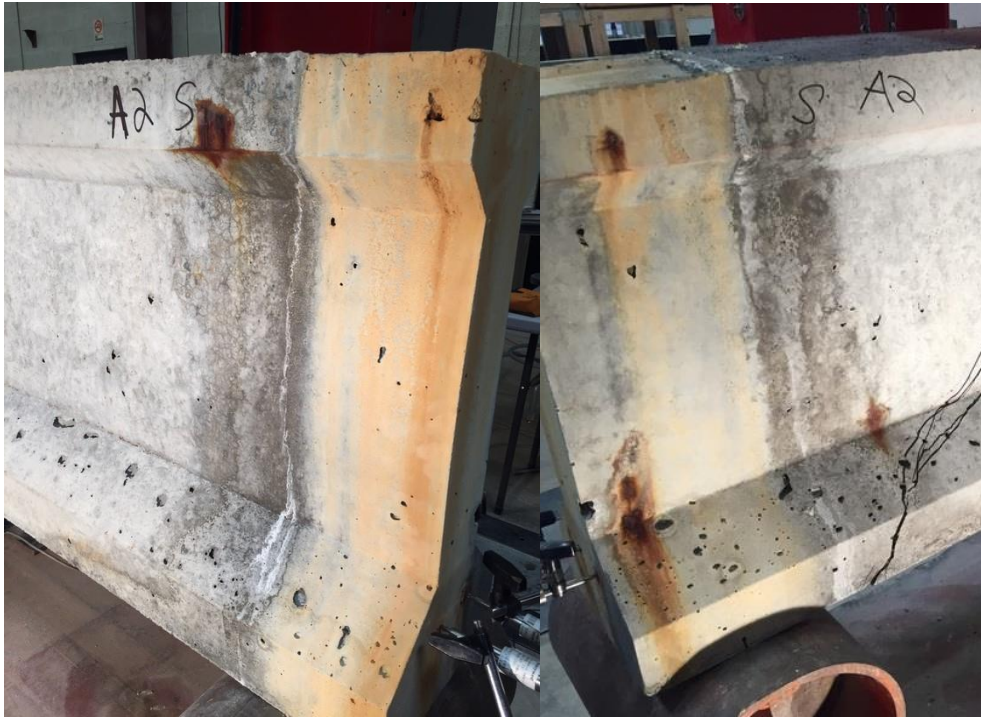
regimen, the girders were removed and prepared for shear testing. Figure 2 is an example of a corroded beam end after six months of the accelerated corrosion process. Rust staining is clearly visible on the surface of the beams at the location of the mild steel shear reinforcement and below the exposed strand ends. An autopsy of the corroded specimens to determine how far the corrosion extended into the beams was not conducted during this analysis.

Figure 2. Example of a corroded beam end after the accelerated corrosion process.

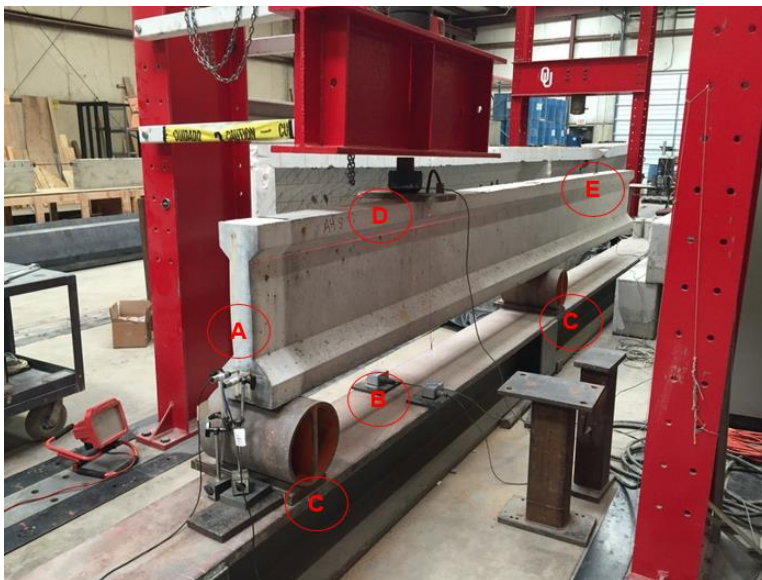
Deflection at the load point was measured using wire potentiometers (wire pots) on each side of the beam. Strand end slip was measured using linear voltage differential transformers (LVDTs) attached to the prestressing strands on the non-corroded end and placed touching the strand ends on the corroded end. Manual deflection measurements were also taken after each load increment using a steel ruler. Visual mapping of cracking was conducted during the testing by marking cracks with a permanent marker and noting the load increments. Data were collected from all instruments during testing using a single data acquisition system. The data were used to compare the findings to the nominal strengths calculated using the ACI¹³ and AASHTO LRFD¹ methods and to identify the failure mechanism. A strut and tie model was also considered for the beam end region to account for the loading configuration creating a discontinuity region at the end of the beam. The results of tests of the undamaged ends of the girders were compared to tests of the corroded girder ends to identify differences in performance. Figure 3 illustrates the shear test setup.

Figure 3. Typical shear test setup looking towards the north – (A) LVDT 1 & 2, (B) wire pots 1 (west) & 2 (east), (C) supports at 9 ft center-to-center, (D) single load point with load cell at 41 in. from end of beam, and (E) 8 ft - 8 in. overhang of the beam

Following the accelerated corrosion period for the 2 month, 4 month and 6 month specimens, each end of each exposed specimen was tested in shear. A three point bending arrangement using a hydraulic actuator to apply load to the girder specimens was used and the untested end of the beam was cantilevered over the support to prevent damage during the first test of each specimen. The loading arrangement for shear was based on a shear span to depth (a/d) ratio of 2.0, intended to induce a bond-shear type failure. However, the chosen a/d ratio is at the border line of creating a discontinuity region for the entire section between the applied load and the nearest support, which could affect the applicability of typical capacity prediction equations. The support nearest the load point was located 4 in. from the end of the beam and the center-to-center distance between the supports was 9 ft, leaving 8 ft - 8 in. of overhang on the untested side. A single point load was applied through a 6 in. wide plate, centered 41 in. from the end of the beam. Sand was placed between the load plate and the beam to ensure uniform load distribution. The girders were loaded in 5000 lb increments before initial cracking and 2000 lb increments after initial cracking until failure.
